Tips from the gasket expert

Leaks in the pressure oil area after a short service life

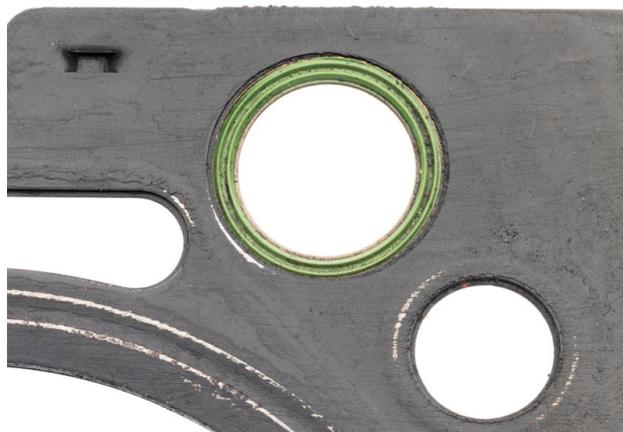
Figure 3 shows a cylinder head gasket in which leakage occurred in the pressure oil area after a short service life. In this case, a chemical sealant was applied in addition to the elastomer sealing element. This improper use of sealant exposes the mating sealing surface of the cylinder head to impurities, and the resulting condition of this surface causes the sealing function to fail after a short period of operation. This is clearly visible in the indentations (scoring) on the cylinder head gasket.

Figure 3: Impurities resulting from chemical sealant on outer edge of green elastomer sealing element and on sealing surface

Sealing compound is not normally used in the cylinder head gasket assembly, unless the engine manufacturer specifies this explicitly for a precisely defined area. The surface quality and warpage of the sealing surfaces must be inspected carefully. The cylinder head will be resurfaced by a professional engine repair shop with the necessary high-precision resurfacing machines.
